## V. DRAINAGE ANALYSIS

District 3 Sidewalk Study - Phase III

## District 3 Sidewalk Study-Phase III

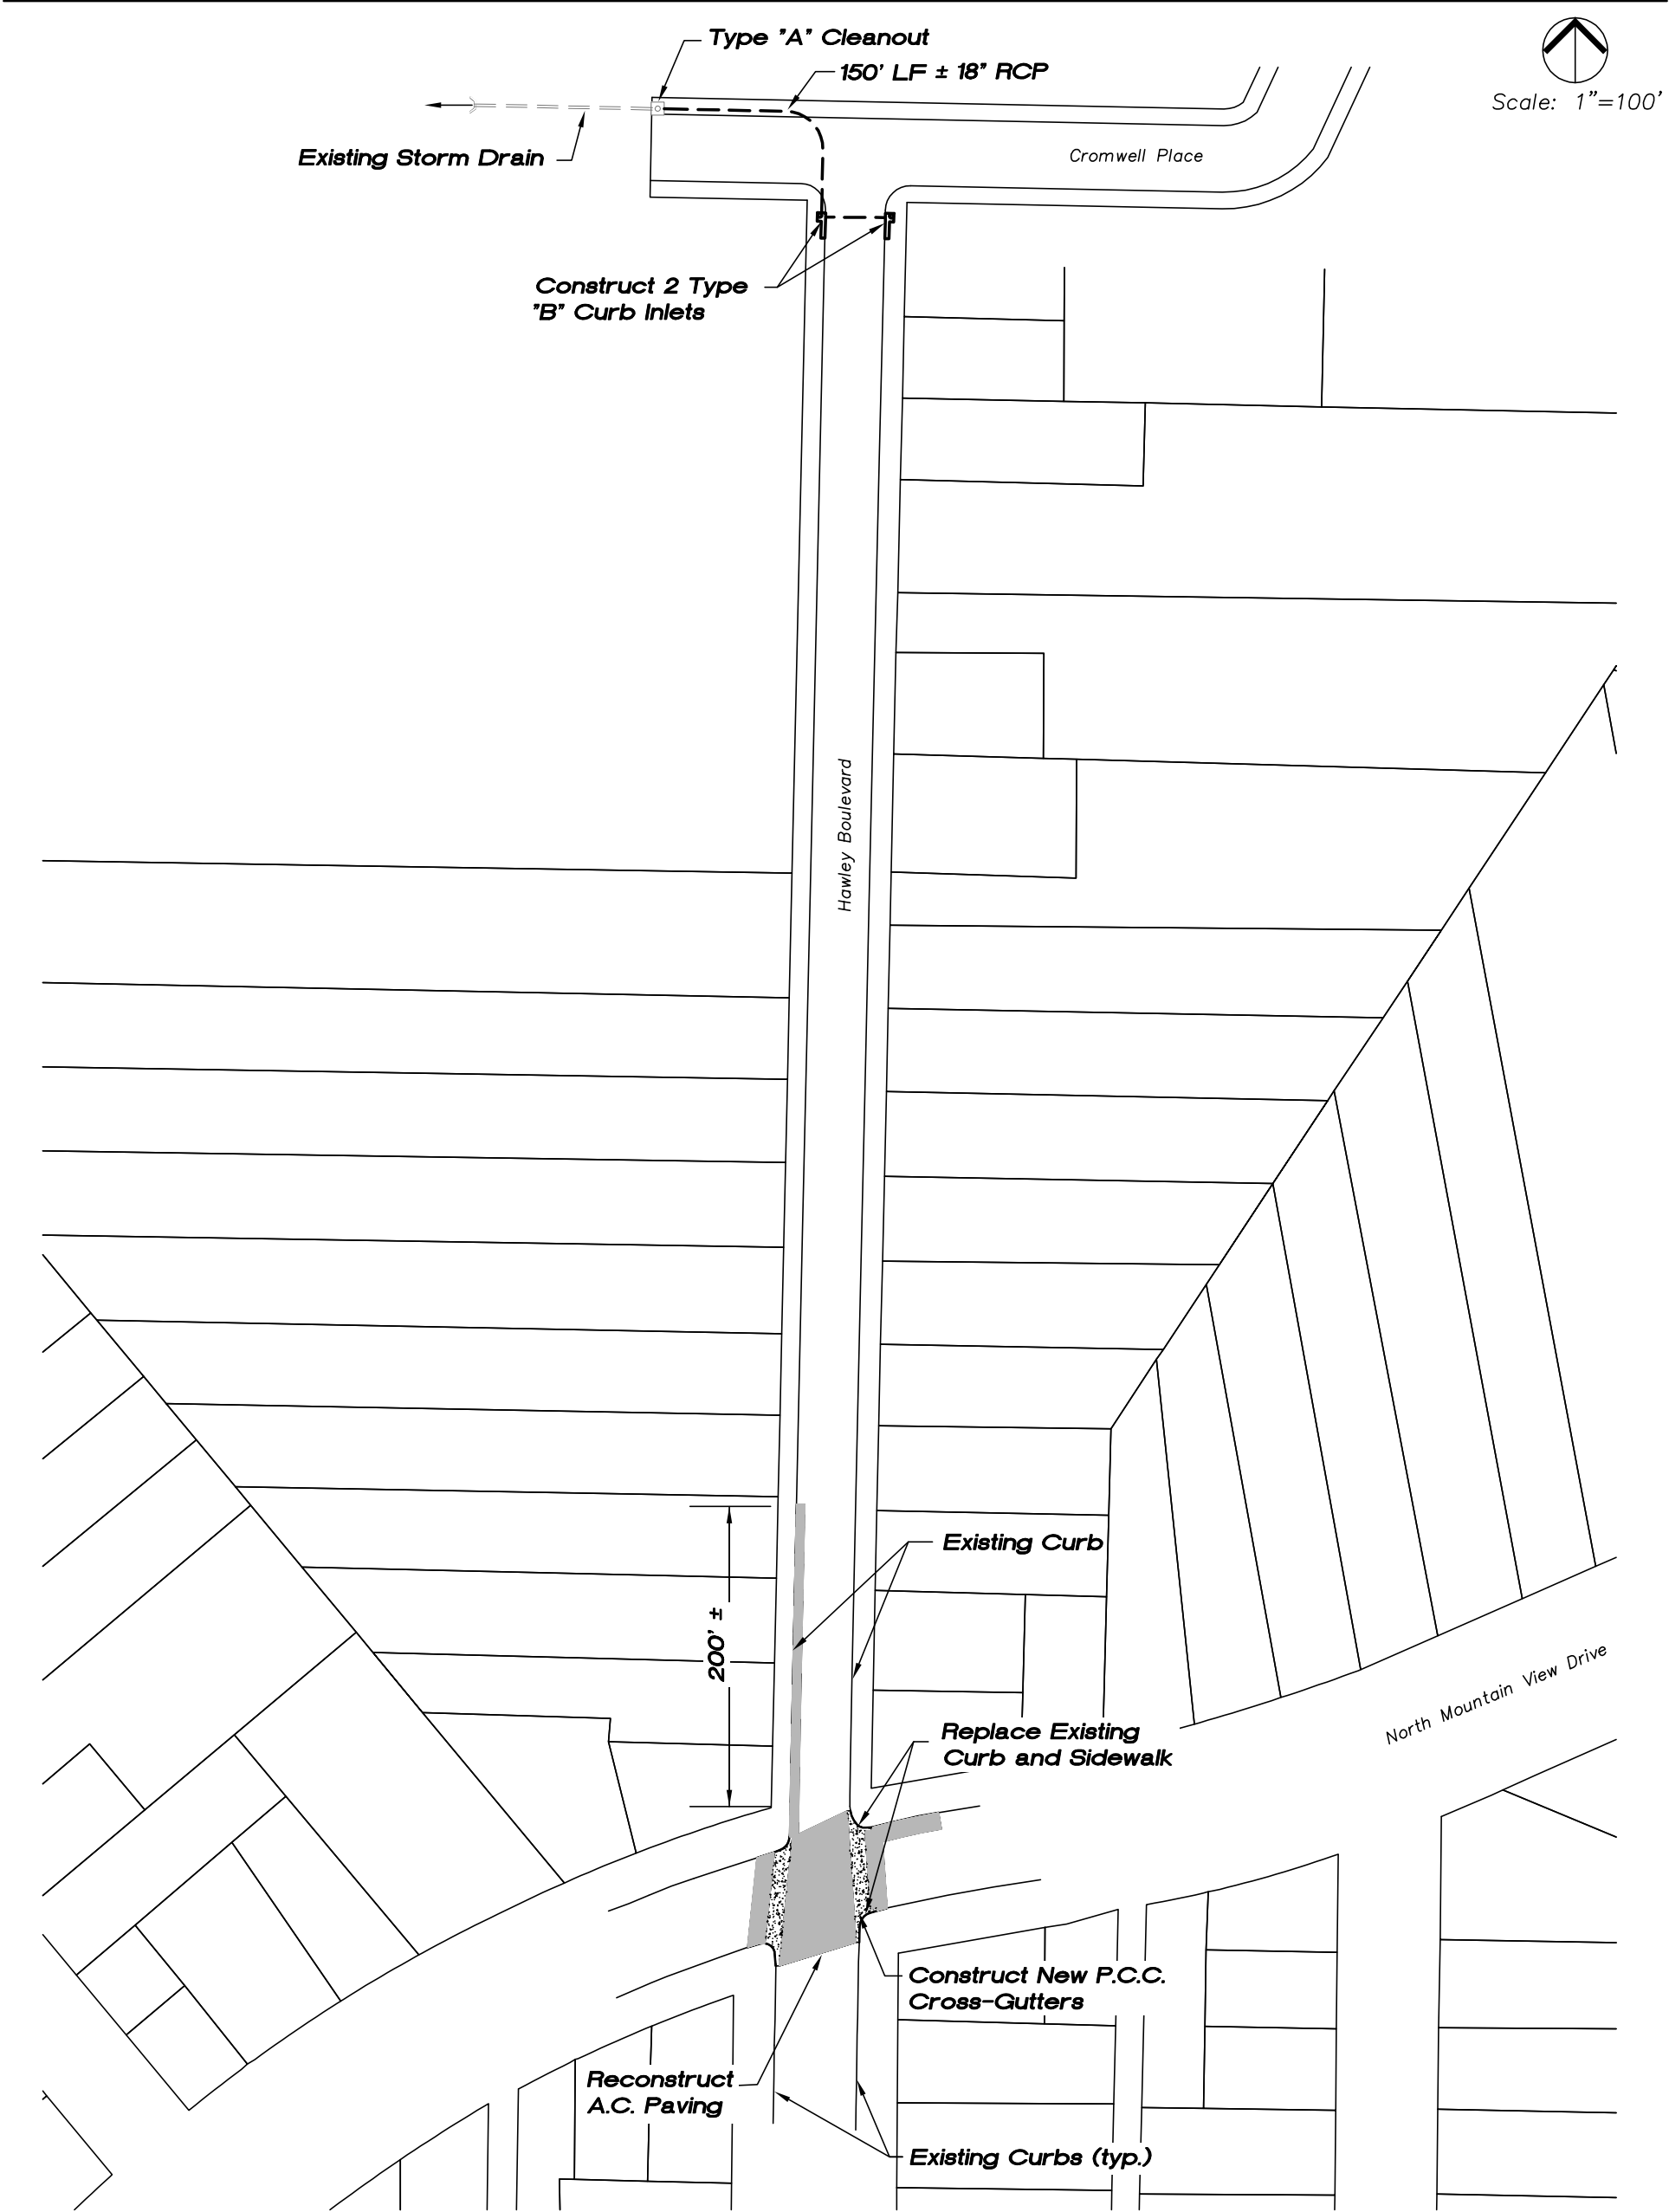
The intersection of Hawley Blvd. and North Mountain View Drive was identified by the Normal Heights Community Association as having an especially severe chronic drainage problem. The intersection is equipped with non-standard “pass-through” drainage tubes at all four curb returns. These do not appear to provide any useful function since they are below the elevations of the adjacent gutters and partially plugged. KHA performed field surveys which revealed that some of the street pavement is actually above the adjacent sidewalk and residential property.

In addition, the adjacent streets lie at near-zero slopes. Some of the existing top-of-curb elevations near the curb returns were found to be at essentially the same elevation as the gutters 100 feet north of the intersection, indicating that positive surface drainage is not achievable under normal design standards. Also, the crowned centerline of North Mountain View Drive is higher than the sidewalks at the two southerly curb returns. Thus, the road essentially forms a dam that causes persistent flooding of the sidewalks and adjacent yards at the two south corners.

From an examination of the surrounding topography, it appears that this intersection was historically intended to drain toward the north. This drainage pattern was probably never well developed due to flat terrain, and years of repaving projects have added to the deficiency.

The proposed improvement project consists of constructing new concrete cross gutters in a north-south direction across the intersection on both sides of Hawley Blvd. A strip of pavement would be removed and replaced along the sides of Hawley Blvd. and within the intersection to obtain positive drainage toward the north. It does not appear to be physically possible to achieve the City’s usual standard gutter slope of 0.6% in this location. It will be necessary to accept much flatter slopes and there is some possibility that minor ponding may occur along the north leg of Hawley Blvd. even after construction. However, this would be minor in nature and typically would not impact the ability of pedestrians to cross all four legs of the intersection, unlike the existing condition.

Because the project will re-establish the historic pattern of drainage toward the north, provisions should be made for intercepting this runoff at the north end of Hawley Blvd. (within Cromwell Place). This cul-de-sac is served by a pair of outlets, one at each end of the cul-de-sac. In addition, the two curb returns are equipped with non-standard “pass-through” drainage tubes similar to the ones that exist at North Mountain View Drive. The drainage tubes appear to provide little or no useful function. The proposed improvement at this location consists of new curb inlets at the north end of Hawley Blvd. to capture flows before they enter Cromwell Pl. A pipe would then convey the flows to the existing discharge system.

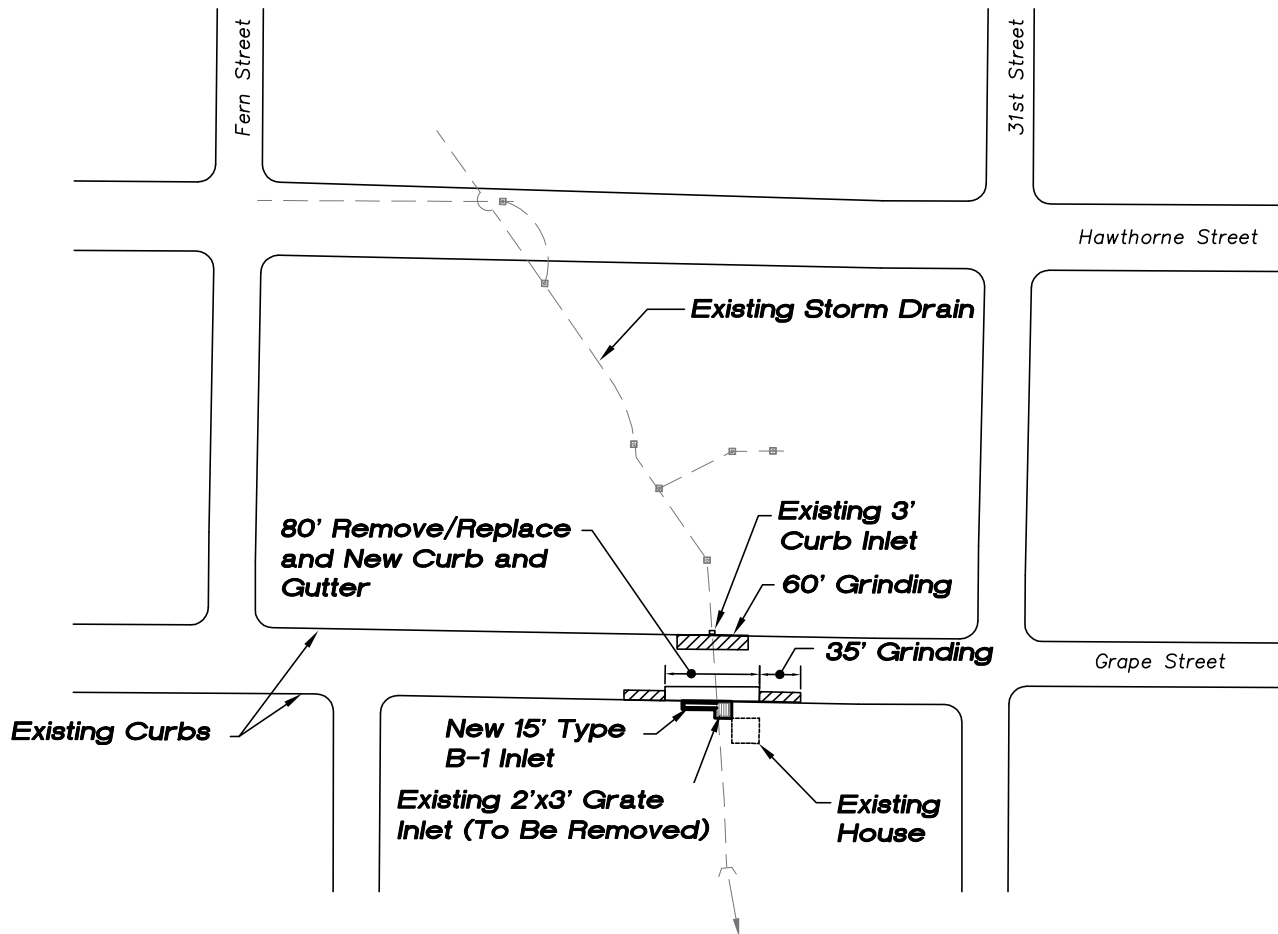
Figure 4

The drainage outlet for Segment SP49 is located at a low point along Grape Street in South Park. This location is in a canyon crossing where the street slopes down steeply from each side. The runoff is collected by curb inlets on both sides of the street which are not large enough to handle large storms without overflowing. Of particular concern is the south side of the street, where there is a near-zero curb height, resulting in probable frequent flooding of the sidewalk. The adjacent residential properties lie below the street, so in addition to the sidewalk flooding, the storm flows also have the potential to impact residences. Fortunately, an existing storm drain pipe is located directly beneath the existing inlets. The recommended improvement consists of enlarging the inlets and, on the south side, grinding the existing pavement to create an adequate gutter and curb height. Because of the potential for residential flooding, this project has been assigned a high level of improvement priority. See **Figure 4, Grape Street Drainage Improvement**.

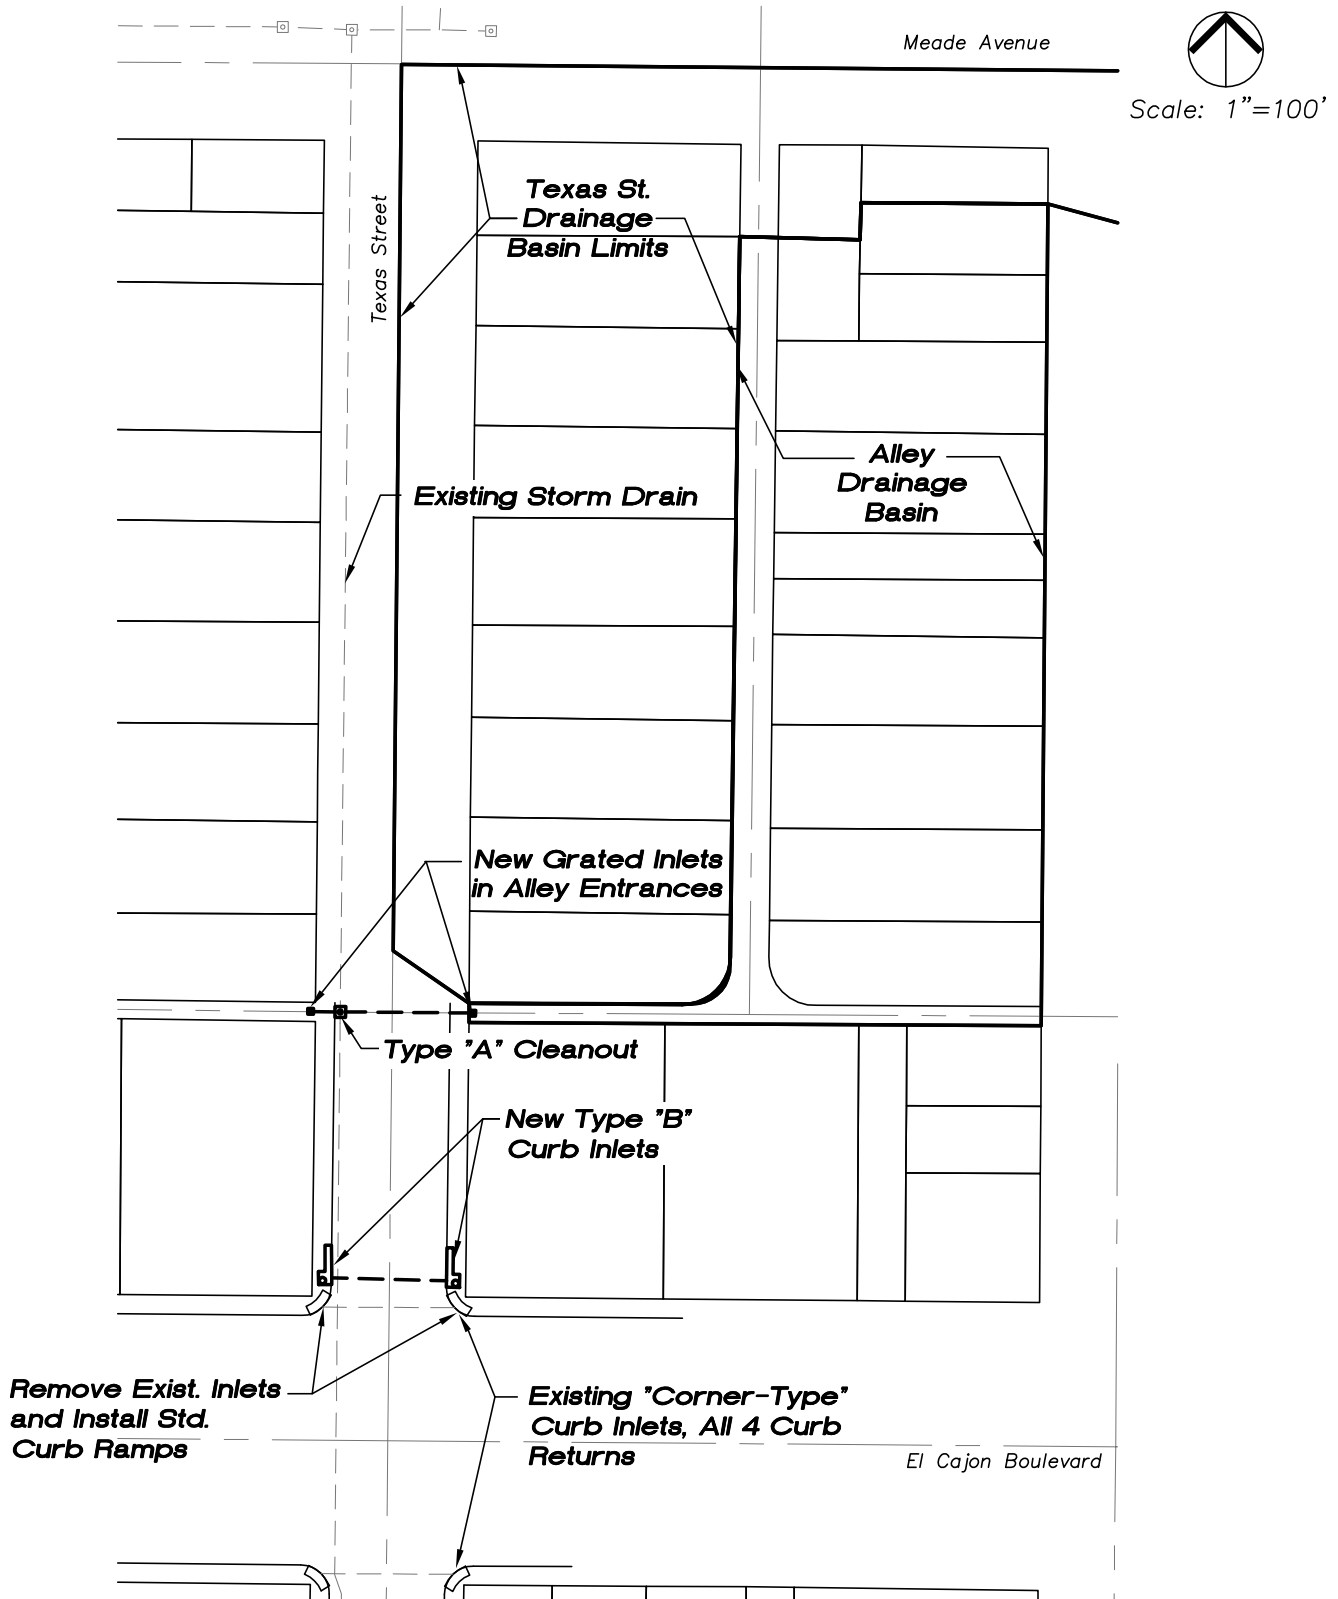
Figure 5

Several unique conditions exist along segment NP92, which is Texas Street just north of El Cajon Blvd. In the mid-block area a pair of alleys enter the street from both sides. These alleys have relatively significant drainage areas of about 1.6 acres. The drainage from these alleys is estimated as 3 cfs for one-year storms, and 7 cfs for 50-year storms. Even the one-year flow from

each alley equals the entire carrying capacity of the substandard gutter along Texas Street, without considering the other flows already being carried in the street. This problem is especially pronounced on the east side, which also serves an upstream basin of 5.5 acres.

On the west side of Texas Street, the upstream flows are not as great, but surface grades are defective, resulting in permanent ponding in the alley entrance which partially blocks pedestrian movement. The City's GIS storm drain mapping indicates a pair of inlets along Meade Avenue just west of Texas, which appear to provide protection to this segment. Field investigation revealed that the inlet on the south side of Meade does not exist, and only a small grated inlet exists on the north side.

Installation of storm drain inlets here could provide two benefits: a curb inlet along the east side of Texas Street could capture the significant upstream flows, reducing the likelihood of flows topping the curb, and a grated inlet in the alley just upstream of the sidewalk could capture the alley flows, so that pedestrians would not need to walk through the stream of runoff from the alley. A connection point for such a system is available about 200 feet away at the intersection of El Cajon Blvd. See **Figure 5, Texas Street Drainage Improvement**.

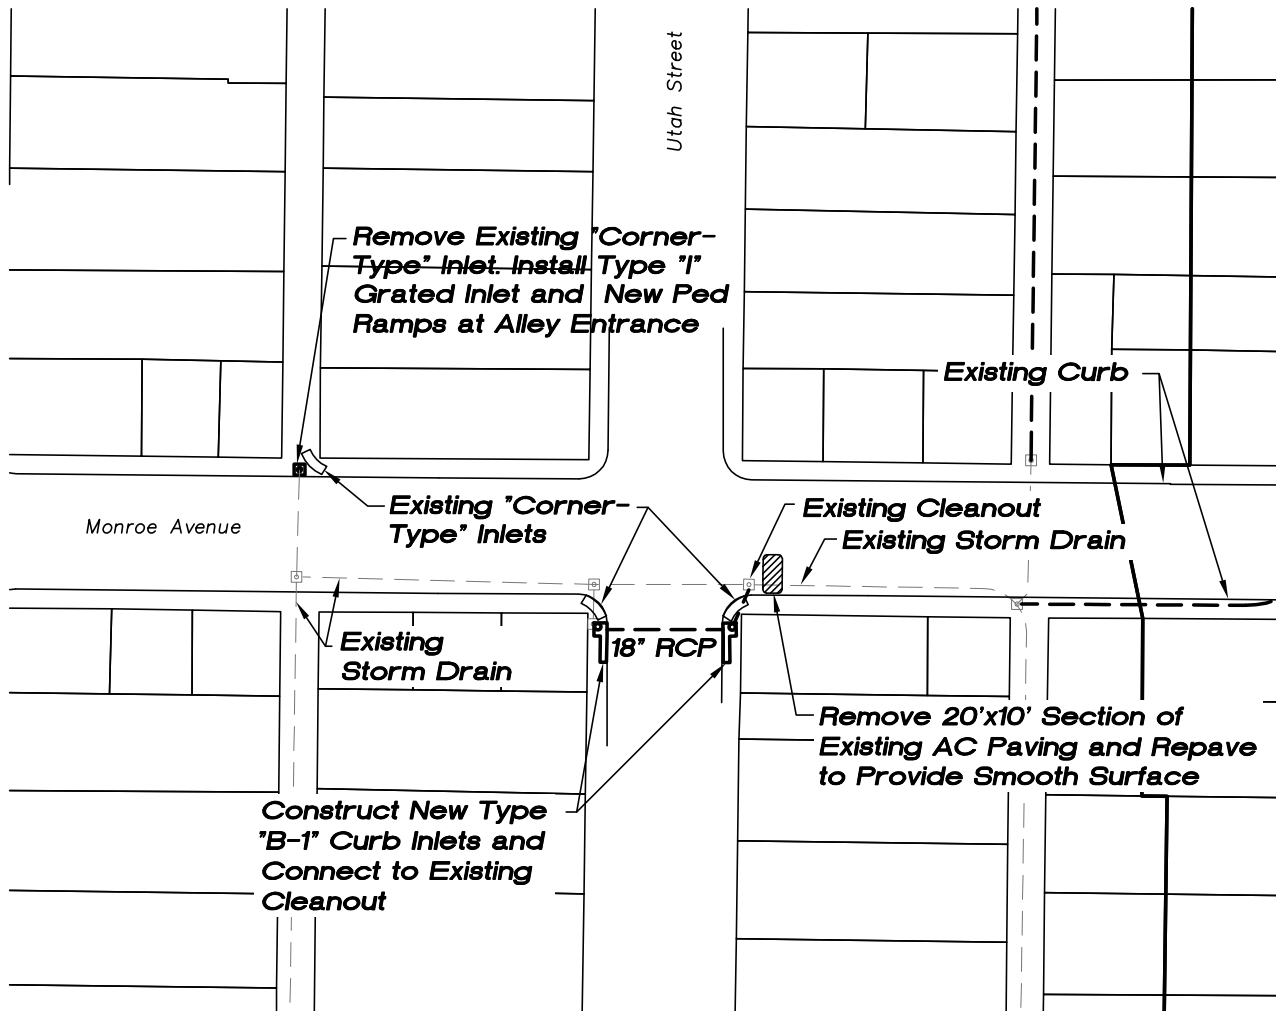
Figure 6

The two southerly curb returns here (west end of segment NP103) are occupied by non-standard “corner-type” curb inlets which preclude construction of curb ramps. The installation of a pair of new Type B curb inlets immediately south of the curb return would allow these older, non-standard inlets to be removed and proper curb ramps to be installed. A severe pavement hump exists near the southeast curb return which does not impact pedestrian movement but does create a poor driving surface for vehicles. This defect could be readily corrected as part of this work. See **Figure 6, Utah Street Drainage Improvement**.

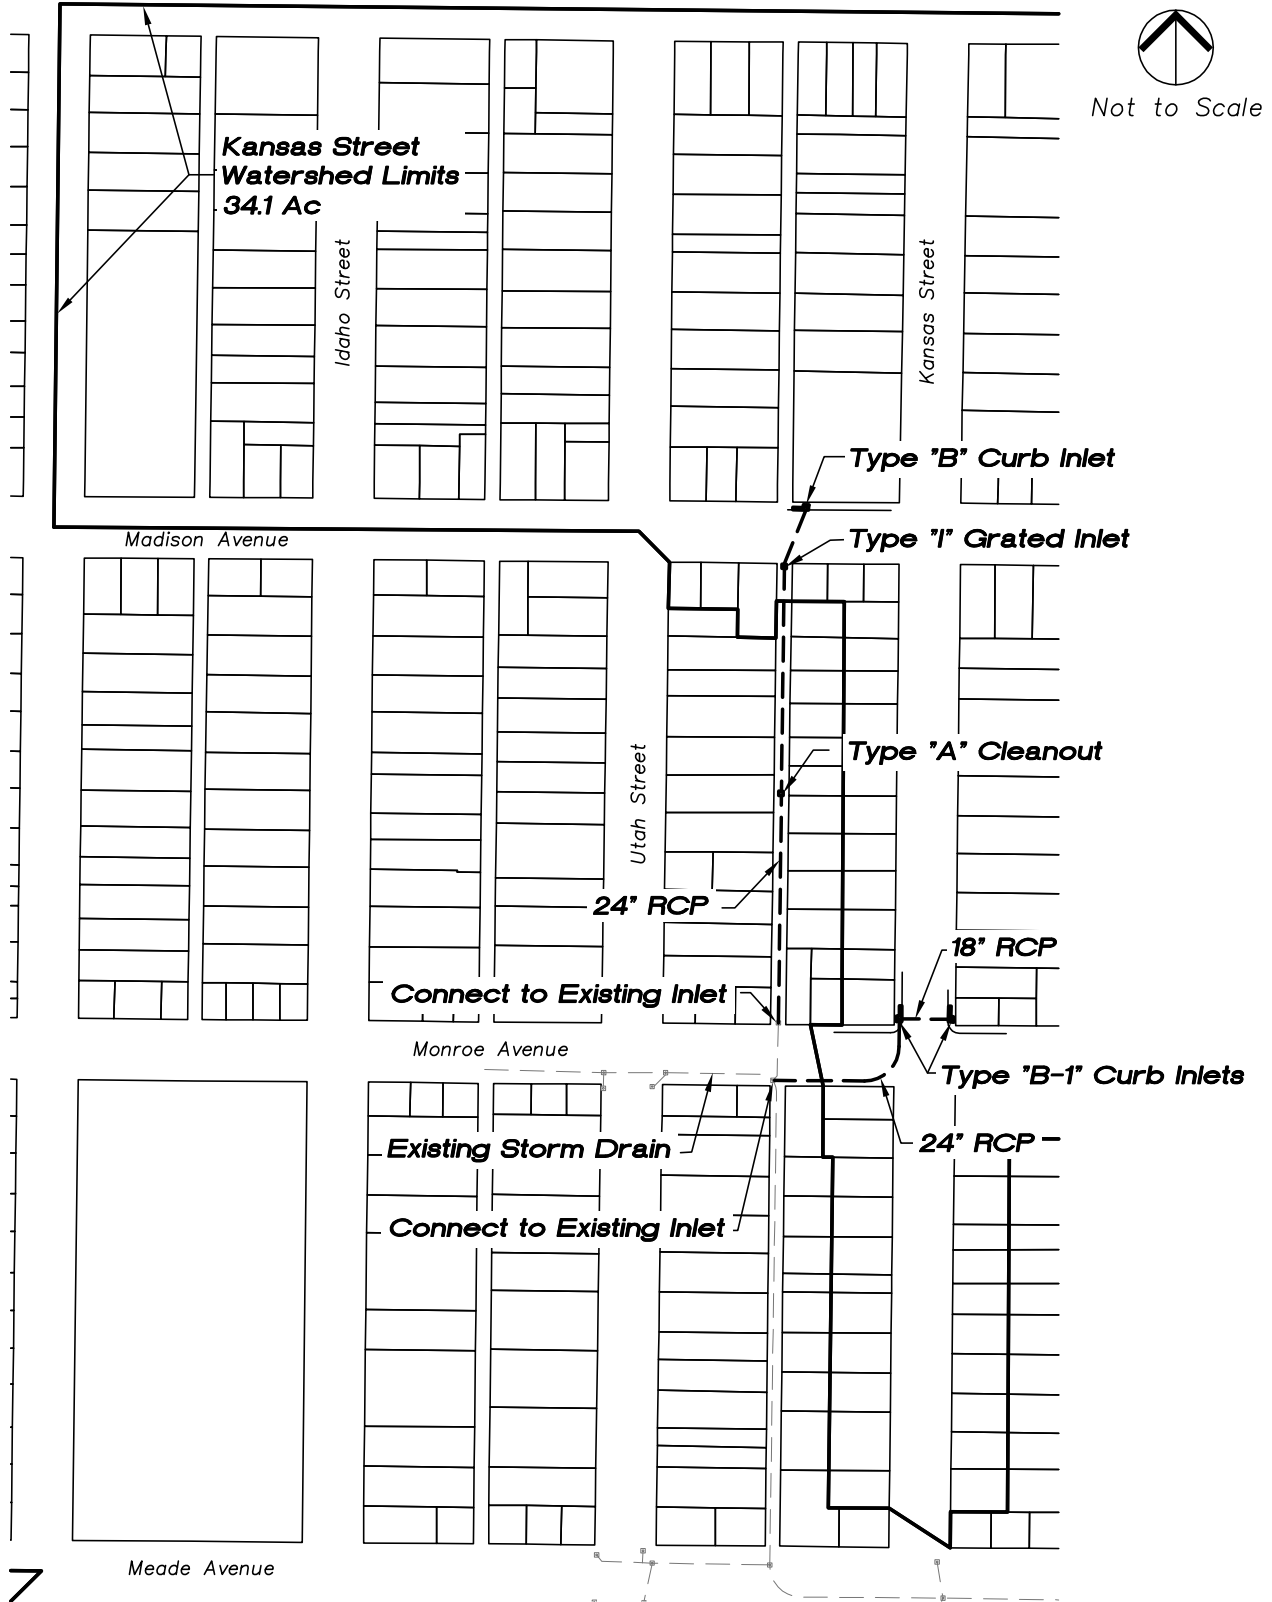
Figure 7

The segment of Kansas Street identified as NP99 drains the largest single drainage basin (34.4 acres) of any segment in the Detailed Study Area. The estimated runoff for even one-year storms is well in excess of the street’s carrying capacity, even if the curbs could be upgraded to full six inch height. In the existing condition, the 50-year runoff rate is about five times the capacity of the street. Furthermore, due to flat grades and limited inlet capacity on the north side of Adams Avenue, the basin may also receive overflow from areas north of Adams.

To resolve these problems, a storm drain extension has been proposed, as shown on **Figure 7, Kansas Street Drainage Improvements**. Because the lack of capacity is so severe at this location, two separate drainage connections are proposed, each of which would capture roughly half of the flows from the basin. However, the two connections will be listed as two separate projects in the list of Improvement Recommendations (Section 8) because if funding were only available to perform part of the work, the shorter and less costly connection provides the greater benefit by intercepting nearly the entire upstream basin.
